ROOF INSPECTION REPORT

Roof Type: Hip Roof

Roof Material Type: Composition Shingle

Date of Inspection: 6/5/23

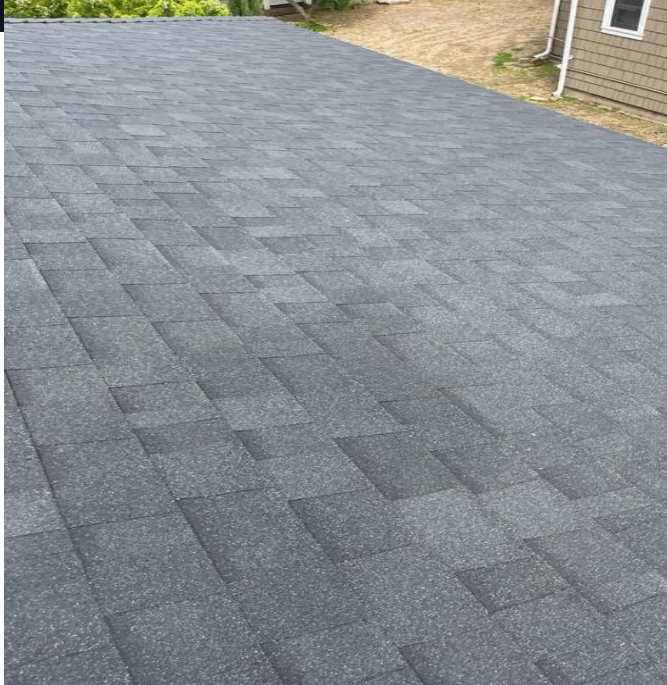
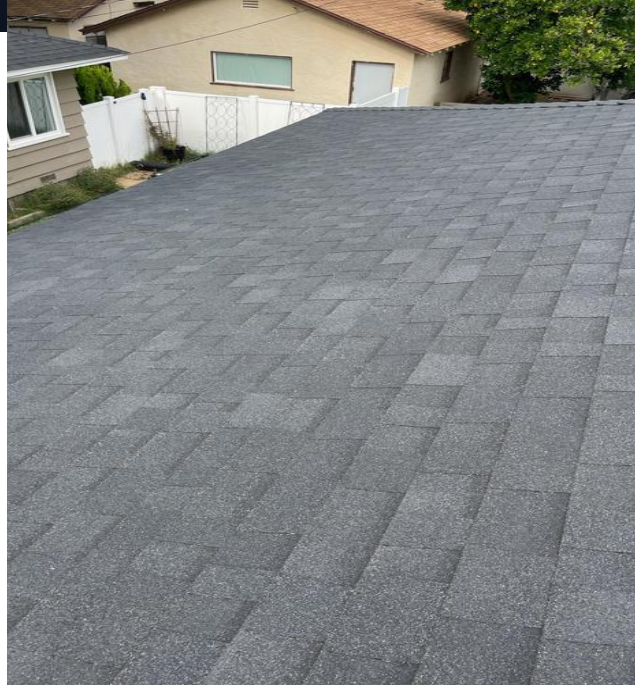
Good granule retention, straight courses.

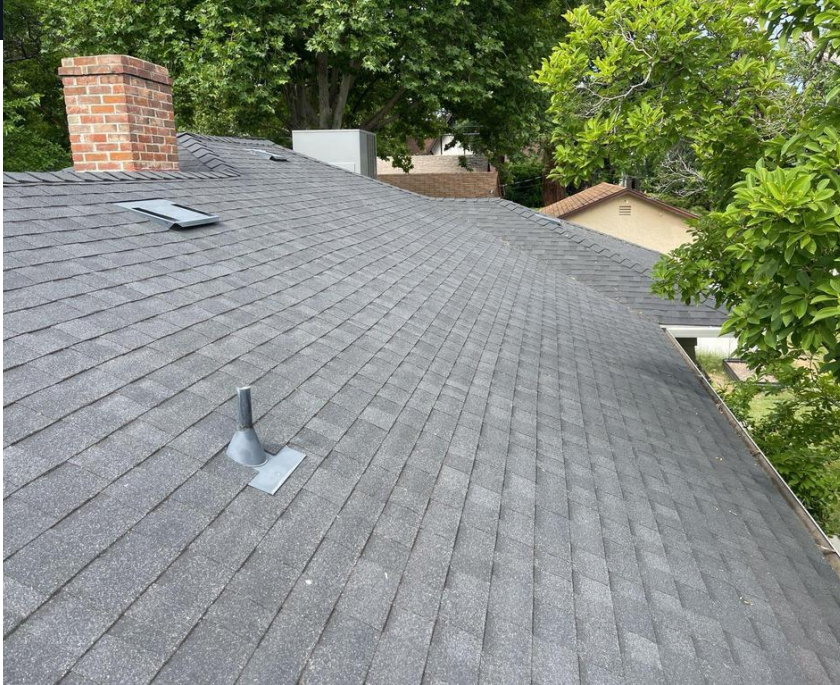
Attic ventilation with O'hagin Vents - will help keep the house cool

There is proper attic ventilation with o'hagin vents. No Ridge vent has been installed, this could be beneficial to roof life expectancy and keeping the home cool in the summer but is not required due to the current attic ventilation.

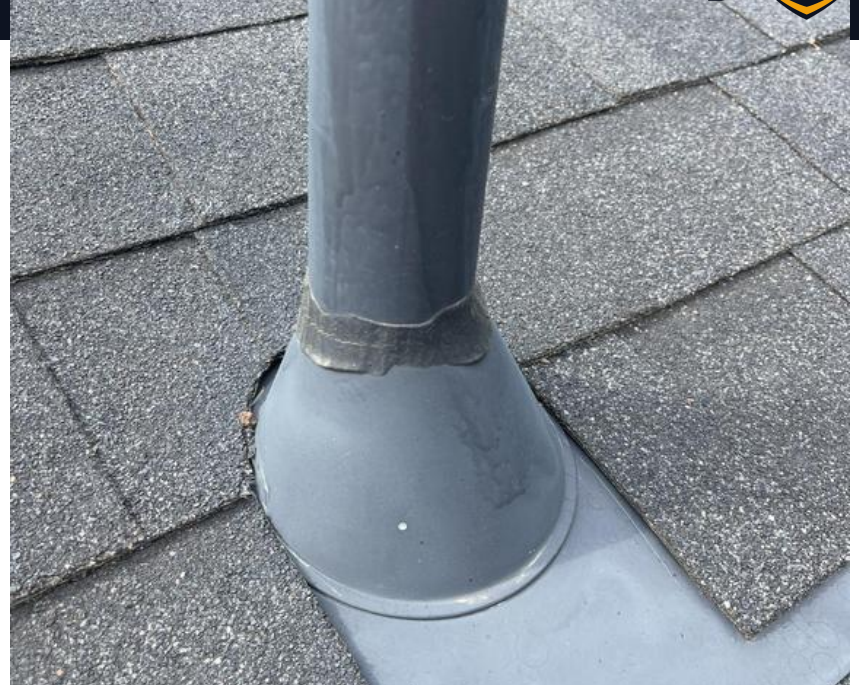
Properly sealed and installed vents

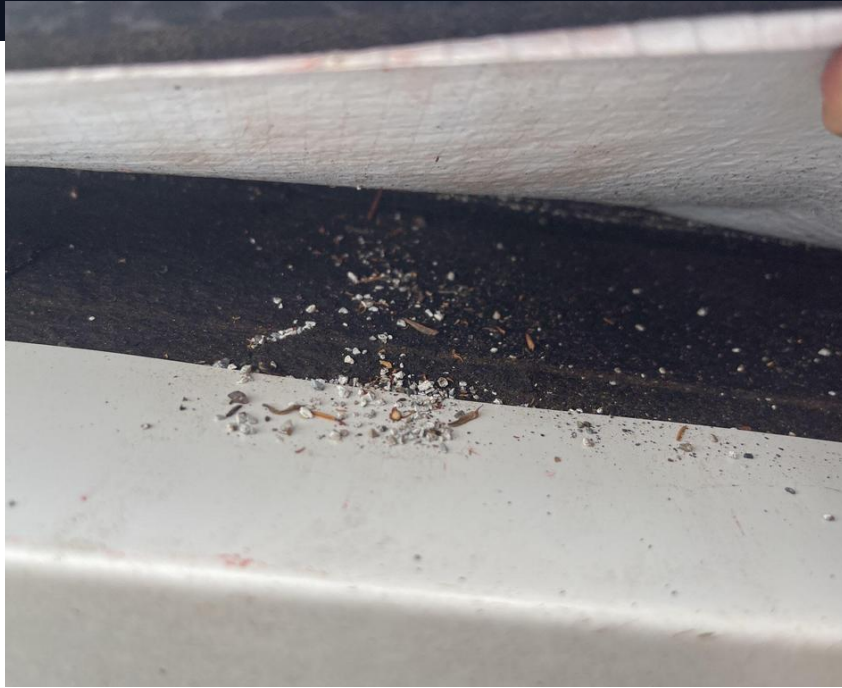
Double Layer Composition Roof System

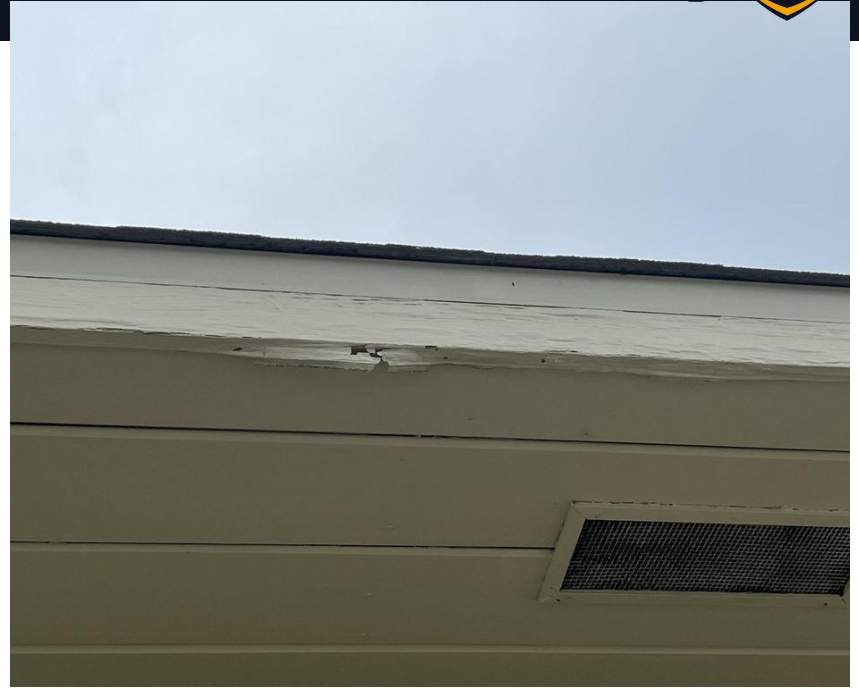
Slight dry rot damage to fascia boards, most likely from previous roof system.

There is some slight dry rot on the northwest corner of the steep slope roof. Due to the condition of the current roof system, the contractor suspects this is from the prior roof system.

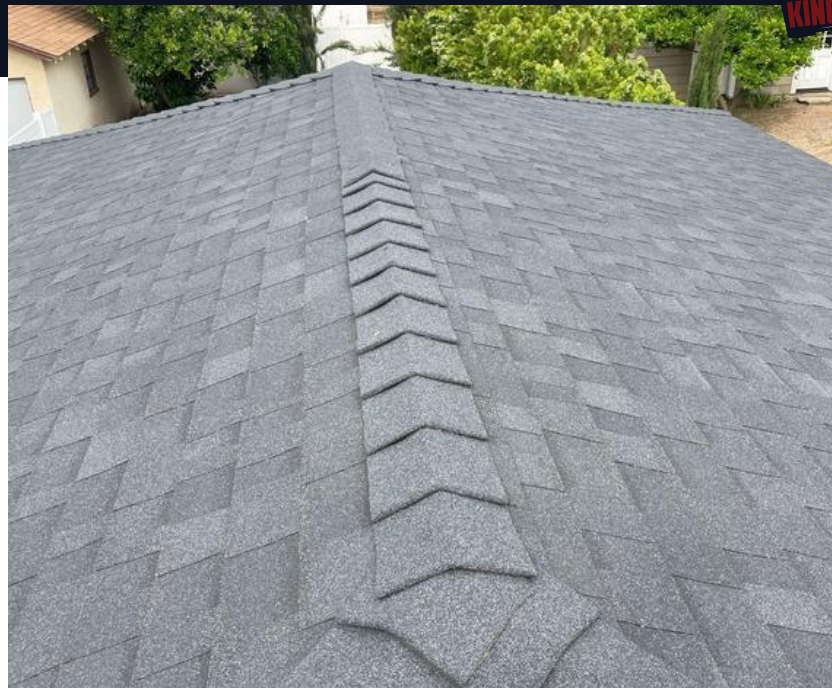
Ridge Vent is not installed on the current roof system. The roof does have attic ventilation and ridge vent is not necessary but could be helpful in the future to help keep the home cool and to increase the life of the roof.

Proper attic ventilation allows the composition shingles to “breathe” from both the top and bottom of the shingle. This can increase the life expectancy of the roof by reducing the amount of petroleum on the shingle that evaporates each year.

10 Inch Bull Nose Ridge Cap - No Ridge Vent

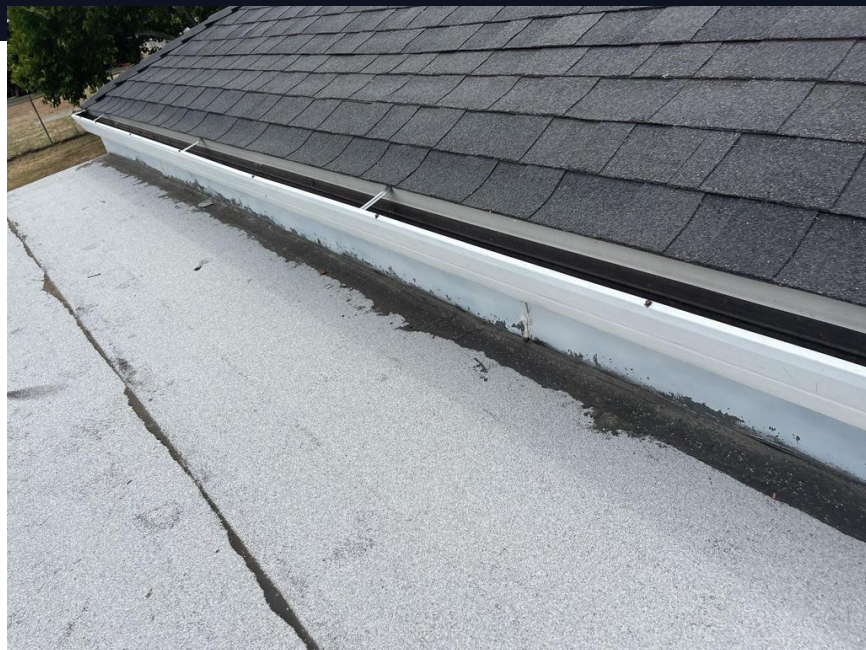
Roof to Wall sealed with mastic - roofing sealant.
This is a temporary repair.

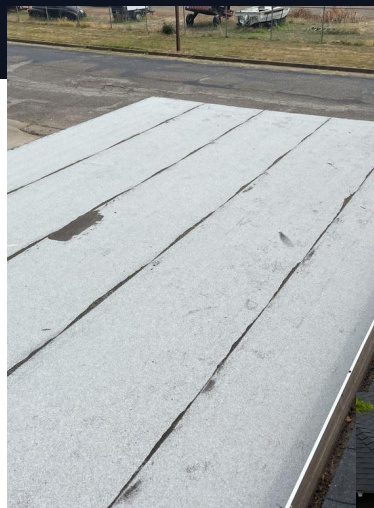
Missing granules.
Previous repairs
visible.

The Patio flat deck roof has “wear and tear” damage as well as visible repairs. Significant granule loss is visible and the contractor recommends it to be replaced.

- Replace flat deck patio roof.
