ROOF INSPECTION REPORT

Roof Type: Hip Roof

Roof Material Type: Composition Shingle

Date of Inspection: 6/5/23

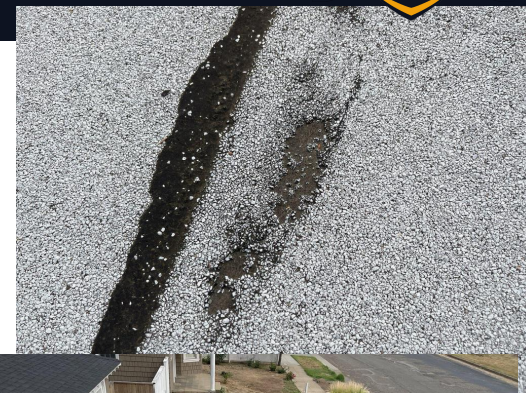
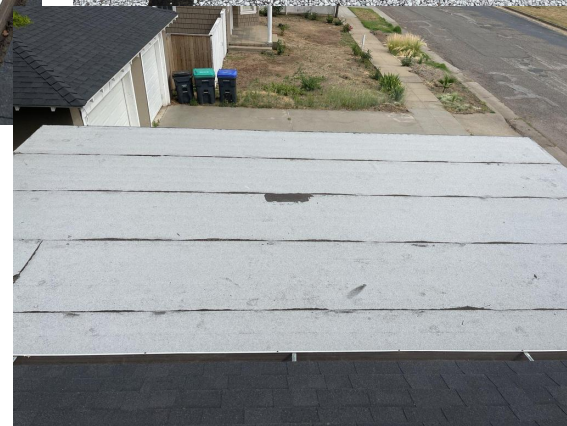
Missing granules.
Previous repairs
visible.

The Patio flat deck roof has “wear and tear” damage as well as visible repairs. Significant granule loss is visible and the contractor recommends it to be replaced.

- Replace flat deck patio roof.
